Reference 2016-03-02 6P01255 Page 1(2)

Determination of radon transmittance

0305 Black, Radex Radon Tape

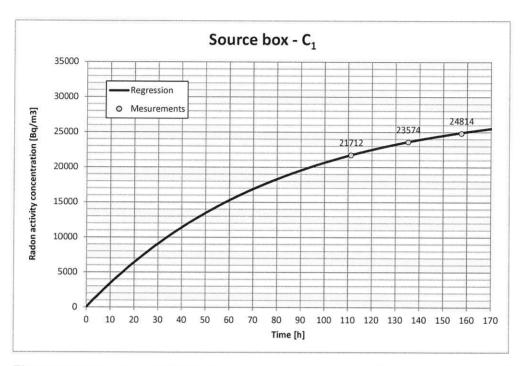
Figure 1 Radon concentration in the primary box: measured daily average values and the regression curve.

box. This difference causes a flow of radon by diffusion through the test material. Only radon gas (Rn) passes through, and not its decay products (RnD). Radon transmittance is measured by measuring the change in radon concentration on both sides of the test material. Figures 1 and 2 show how the radon concentrations build up in the two boxes.

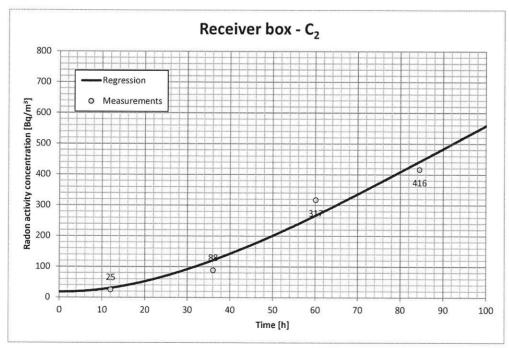
Figure 2 Radon concentration in the secondary box: measured daily average values and the regression curve.

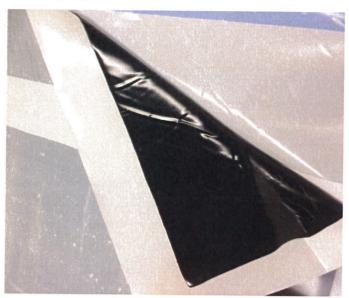
Photographs of the tested material

0305 Black, Radex Radon Tape

The client delivered the material, under the names of 0305 Black and Radex Radon Tape, to SP Technical Research Institute of Sweden on 2016-02-15. There were no signs of visible damage to the material on arrival. The material was applied on a gypsum board during the test, the results is only for the material. The material was tested without joints. See Appendix 2 for a picture of the material.
